Manhole Inspection Summary

Manhole # S37AA1033MH

Location Address: **3501 FRISBY ST**

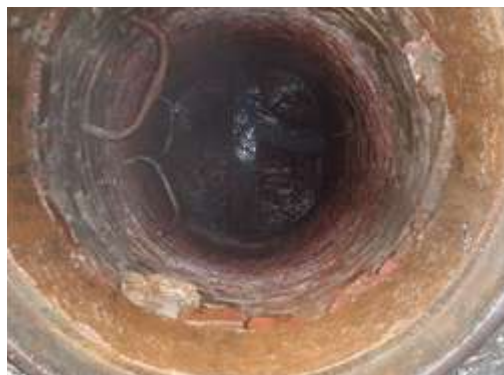
Top View

Corroded steps. Bench debris.

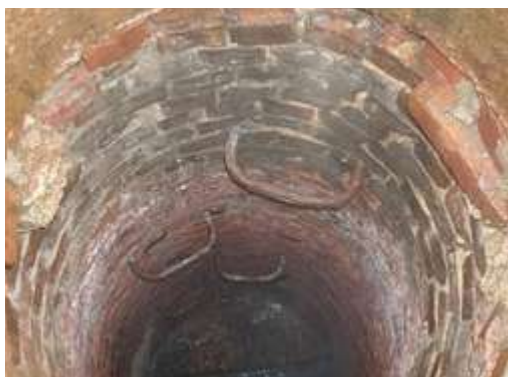
Defect

Frame leaks. Adjustment deterioration, loose brick and infiltration. Corbel and Barrel infiltration.

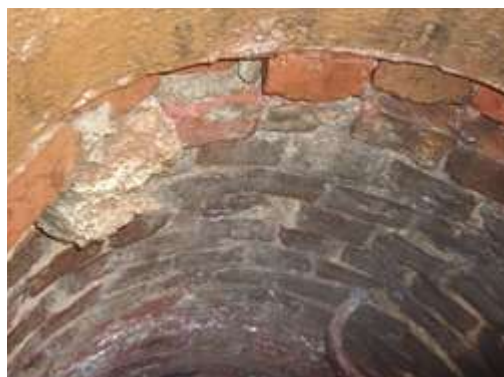
Defect

Frame leaks. Adjustment deterioration, loose brick and infiltration. Corbel infiltration.

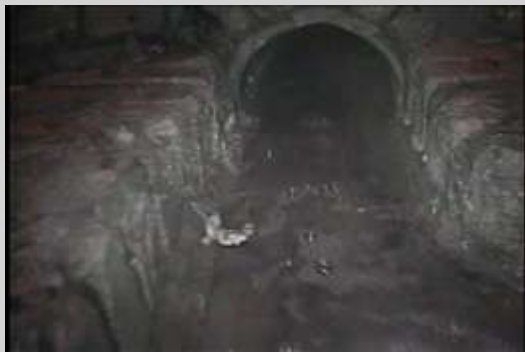
8 in. Circular Gravity Sewer Pipe Out @ 12 O'Clock

Bench and Channel deterioration.

Infiltration: **Evidence** Pipe Seal Cond: **Cracked**

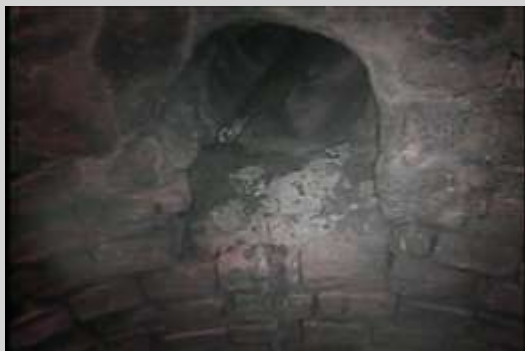
8 in. Circular Gravity Sewer Pipe In @ 3 O'Clock

Barrel deterioration and infiltration.

Infiltration: **Evidence** Pipe Seal Cond: **Unknown**

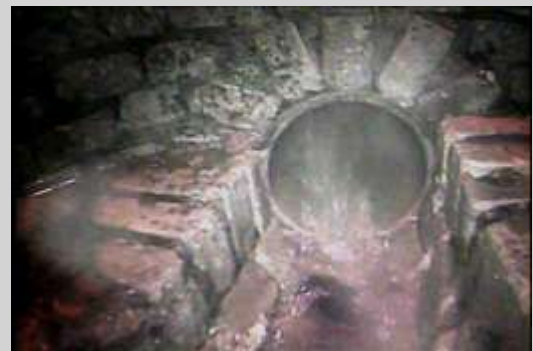
Drop In @ 3 O'Clock

Barrel deterioration and infiltration. Channel deterioration.

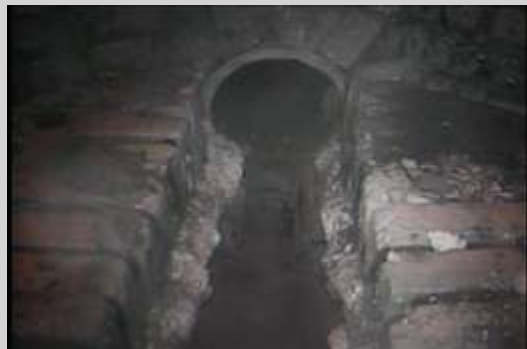
Pipe In @ 6 O'Clock

Barrel deterioration and infiltration. Bench deterioration.

Deposits: ☐ None ☐ Mud ☐ Sludge ☐ Debris ☒ **Grease**

Deposits Extent: **Medium**
